THE RUINS MIXED-USE DEVELOPMENT

Watertown, SD

CONSTRUCTION OBSERVATION REPORT

Project No. 24-020

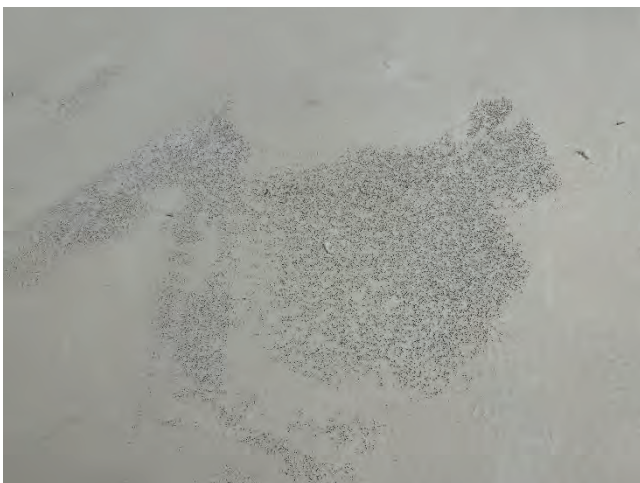
- Bubbles and/or shale/debris observed at the surface of the floor in several areas, resulting in a potential concern with flooring installation.

Observed Gypcrete bubbling in Numerous locations.

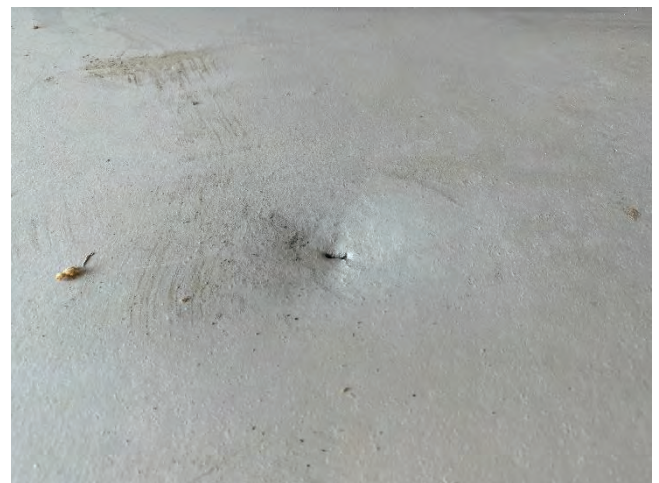
Observed hole in floor in 3rd Floor Unit, Living Room.

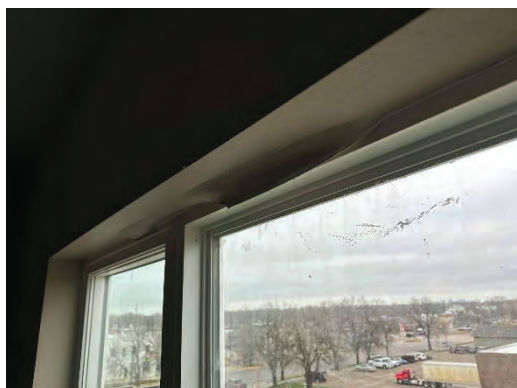
- o Transition from building wrap to masonry block was not terminated properly and could be the source for water penetration in the future.
- o Observed approx. 45-50 windows with moisture penetration on the north and east elevations of the building.

Observed Water Damage

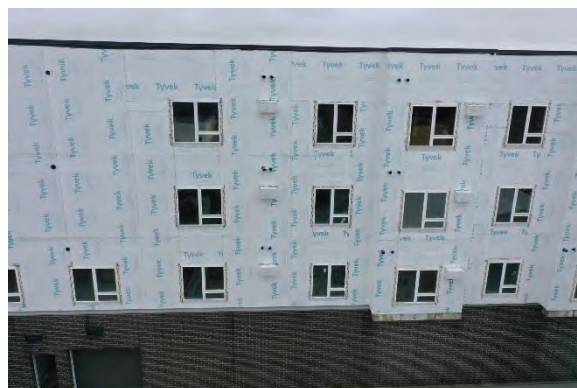
- o Observed various hold down plates not tight to underside of precast.
- o In our opinion, the Tyvek Building Wrap has deteriorated from the time of installation to the time of the inspection. Manufacturer inspection required to determine if current Tyvek building wrap is acceptable for warranty.

Faded Tyvek, 3M Tape on Windows

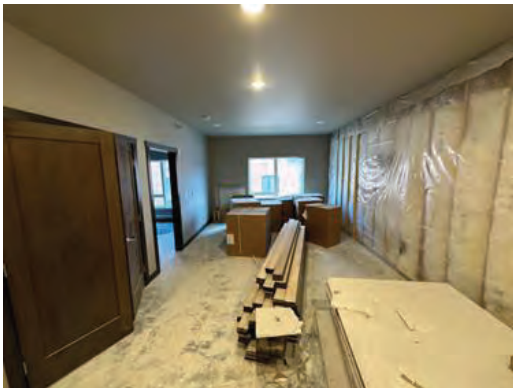
Install all Cabinets, 2nd Floor

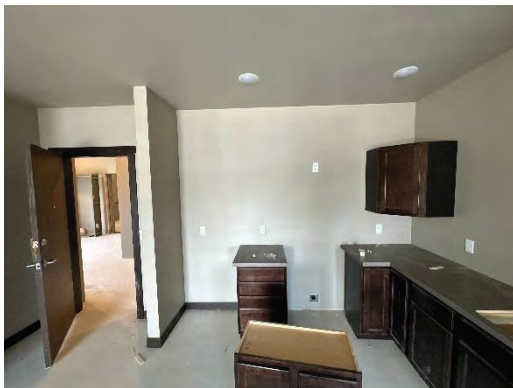
Missing Upper Cabinet, 3rd Floor

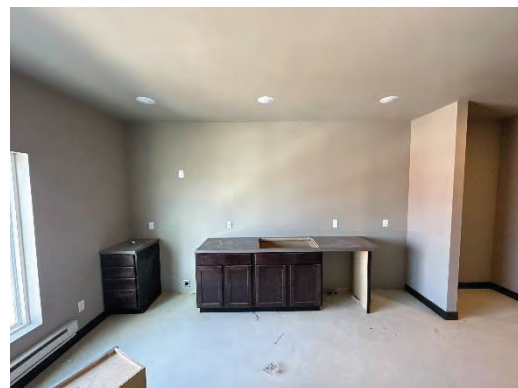
Missing Upper Cabinet, 3rd Floor

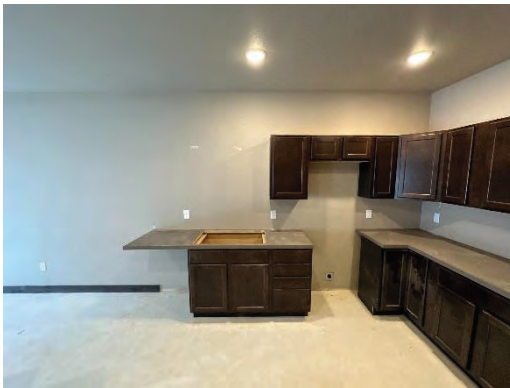
- Observed numerous locations where the overhangs of the countertops were inconsistent. In some cases, overhang of the countertops will prevent installation of the range.

3rd Floor Unit, Adjustment Required

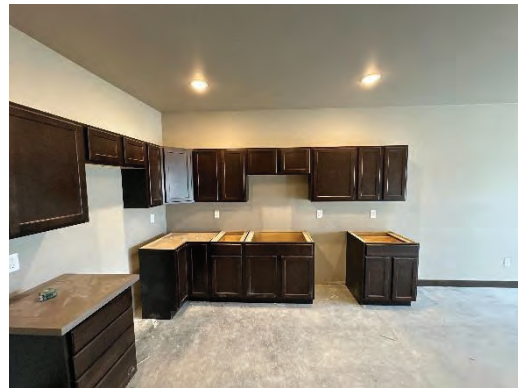
2nd Floor Unit, Missing Top

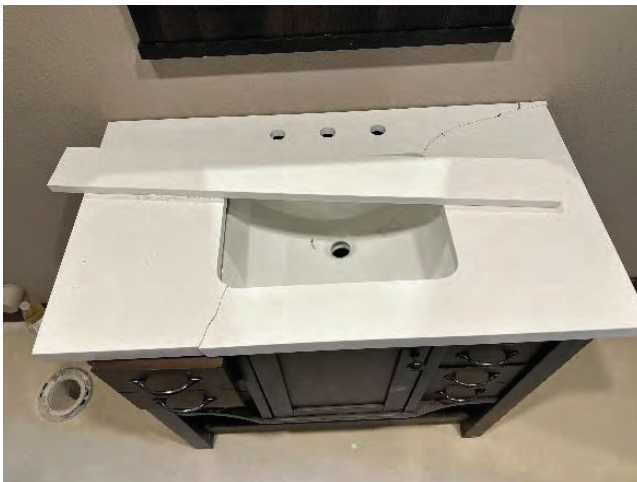
3rd Floor Unit, Damaged Top

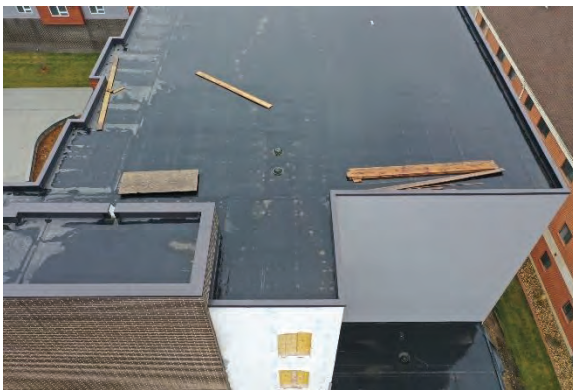
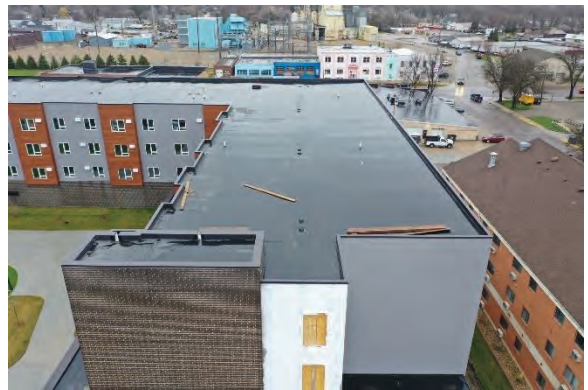
- Excess materials and dunnage located on the roof to be removed.
- Observed several locations of soft spots in the roofing surface, possibly due to gaps in the coverboard.
- Observed several locations of cuts and damage to the low roof on the west side of the building.
- Observed areas of roof that were not draining properly and was holding approx. 1" of water.

Observed standing water in this location

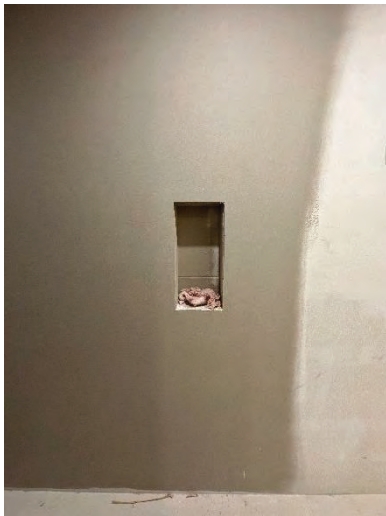
4th Floor Lobby

- Observed floor to accessibility height of fire extinguishers to be higher than typical. This will need to be reviewed with the local building official to determine if the height will need to be adjusted.
- Observed fire extinguisher cabinet openings to be absent of sheetrock on the inside of the opening. If standard fire extinguisher cabinets are used, this may need to be sheet rocked to maintain corridor fire rating. Alternatively, fire rated cabinets may be able to be used. Review with local building officials necessary to confirm.

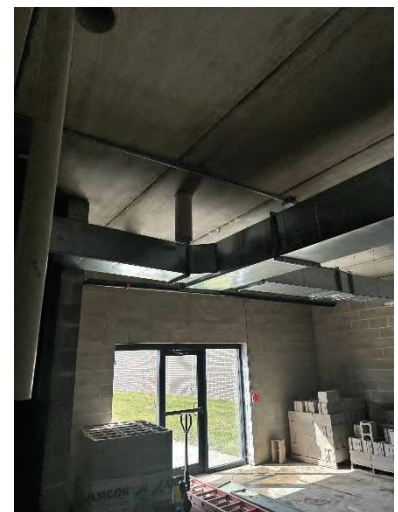
1st Floor, HVAC Incomplete

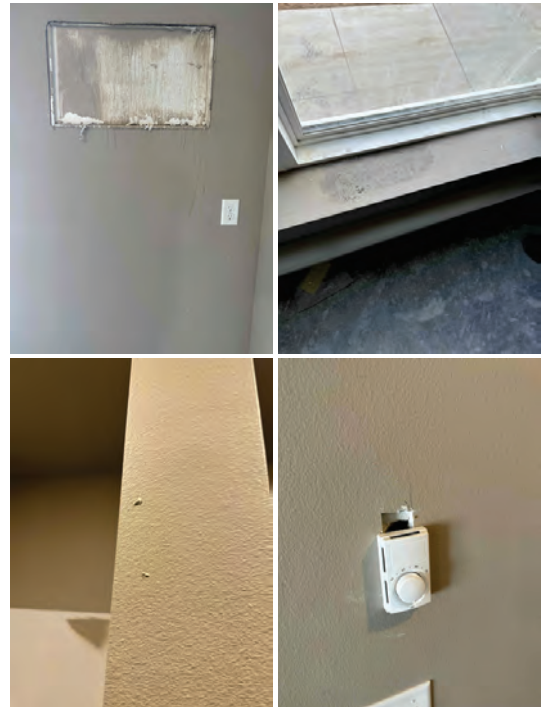
**#512: Repair water damaged drywall at bedroom window**

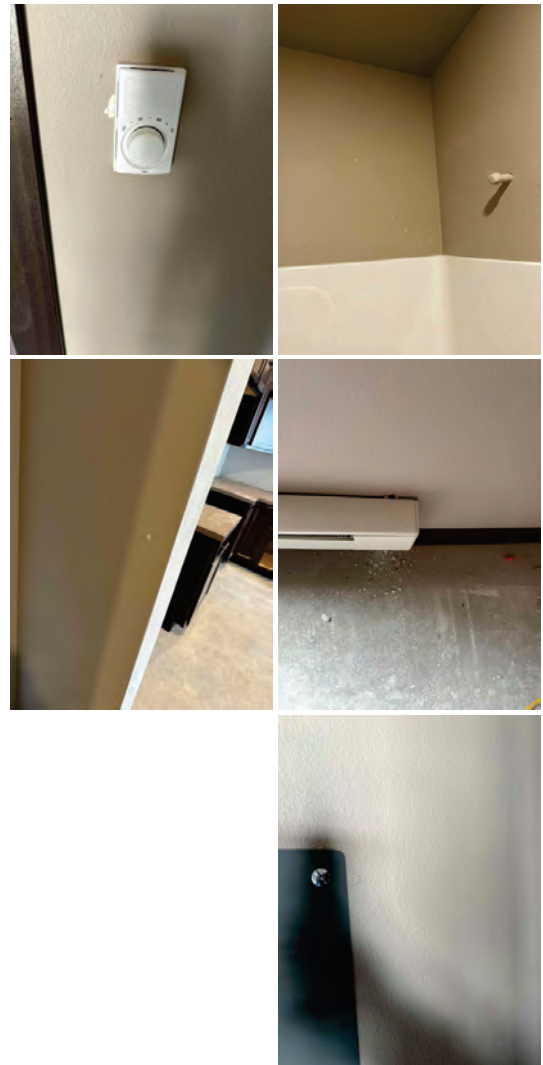
#558: Repair water damaged drywall at bedroom window

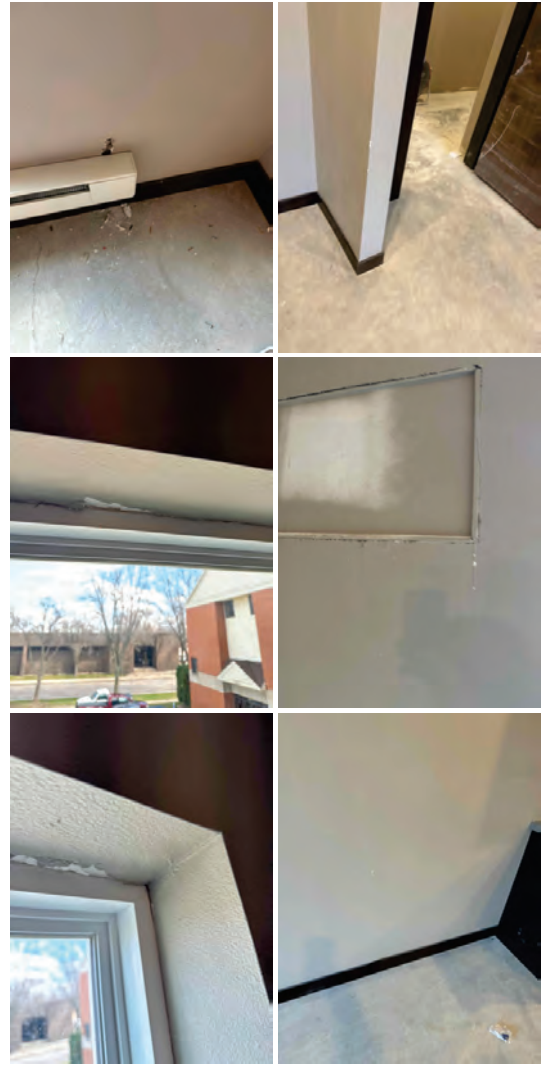
#614: Repair water damaged drywall at living room window

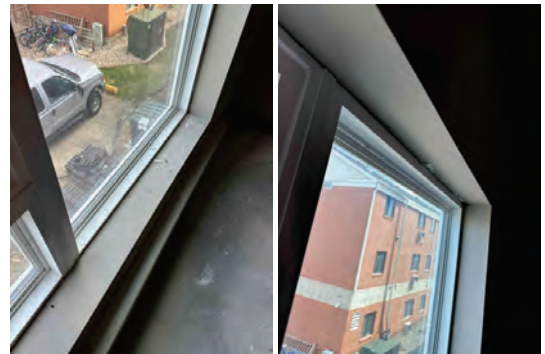
#615: Repair water damaged drywall at bedroom window

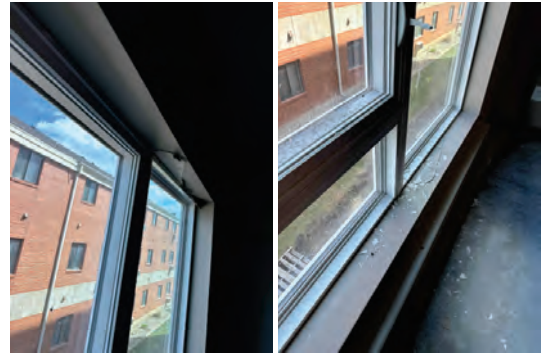
**#639: Repair water damaged drywall at bedroom window**

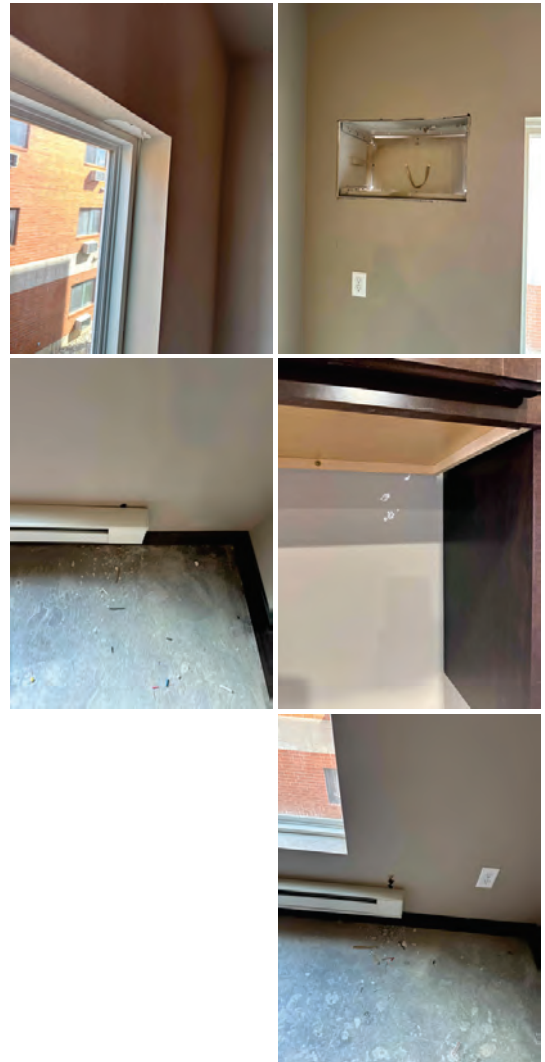
#664: Repair water damaged drywall at bedroom window

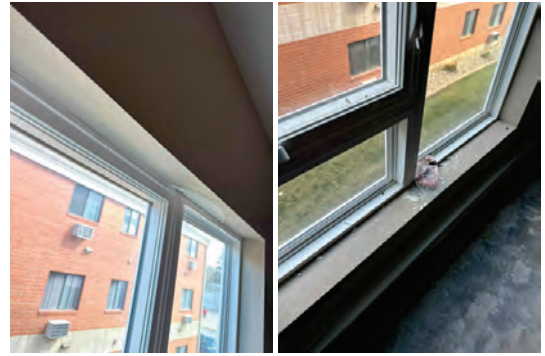
**#680: Repair water damaged drywall at living room window**

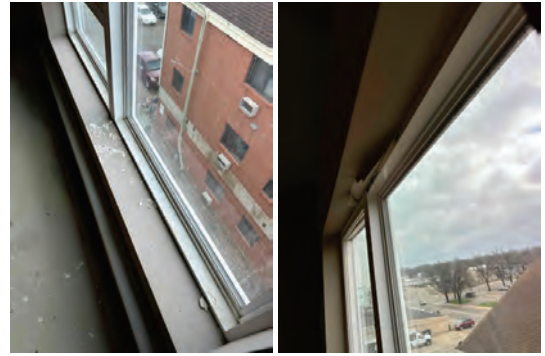
Description:
Window leaking
